An Archæological Evaluation on the west side of Kenilworth Abbey Gatehouse

Bryn Gethin, Archæology Warwickshire

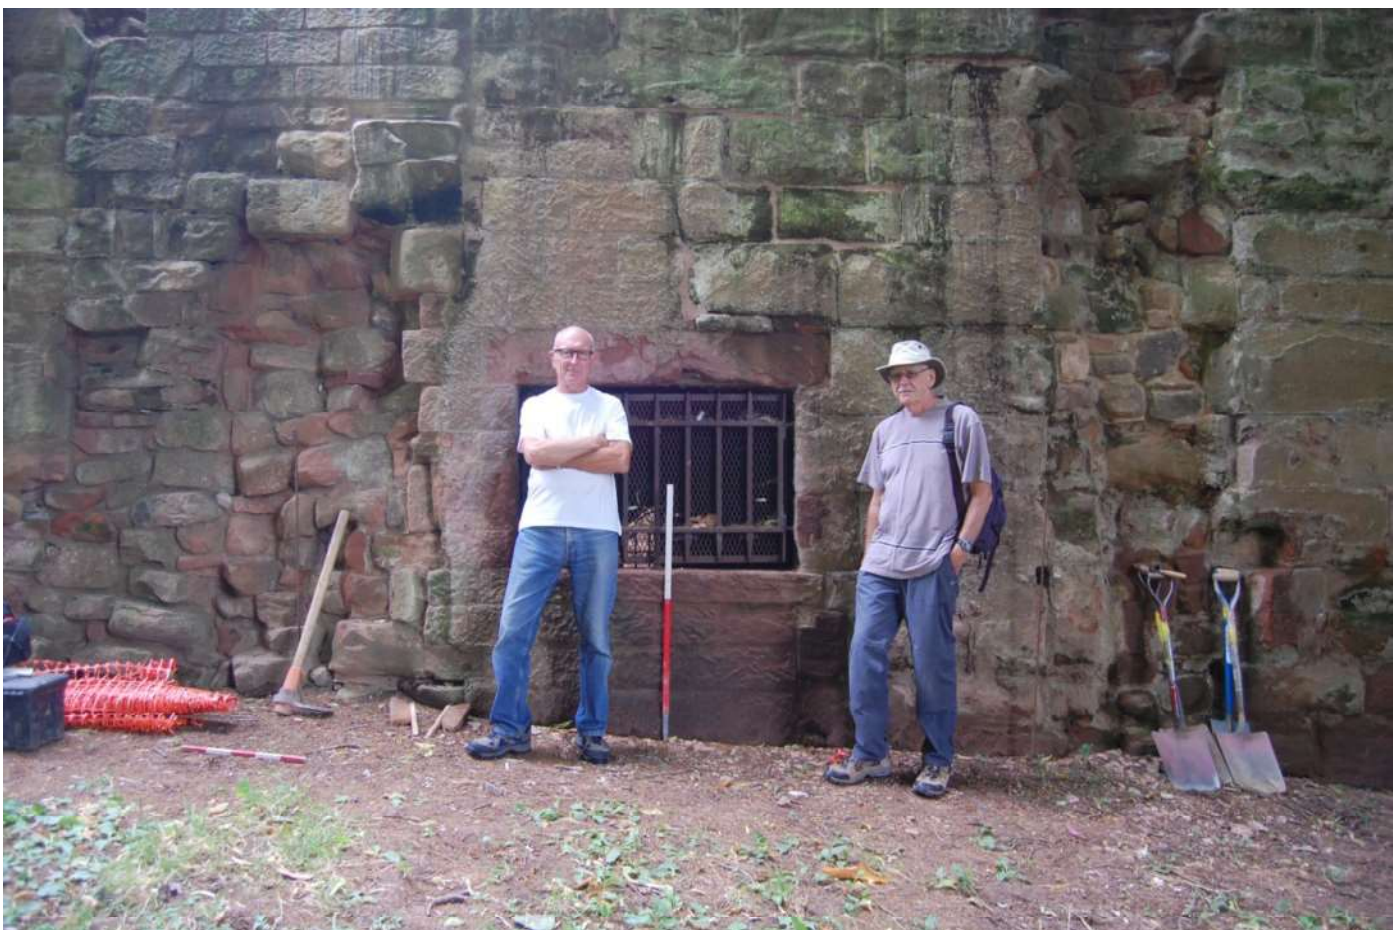
Figure 3

features (Figs 3 and 4) which corresponded with the position of the wall scars. These two features consisted of well-made stone walls, both with double-chamfered plinths which were tied into the plinth revealed on the gatehouse wall itself. They were all clearly contemporary with each other and probably dated to the

rebuilding of the gatehouse under the tenure of Prior Bradway (1361-75). The features appeared to be buttresses although it remains possible that the larger of the two represented the inner precinct wall of the abbey where it met the

The results of the excavation answered most of the questions which had been raised beforehand. They showed why the west face had two large scars in the masonry and also just how well preserved the buried stonework was. It gave a good indication of the original appearance of this side of the building and showed what over 470 years of extra exposure to the elements had done to the upstanding masonry. A possible location for the new electricity service was also indicated between the two probable buttresses, in a position which would cause the least damage to any buried archaeological remains.

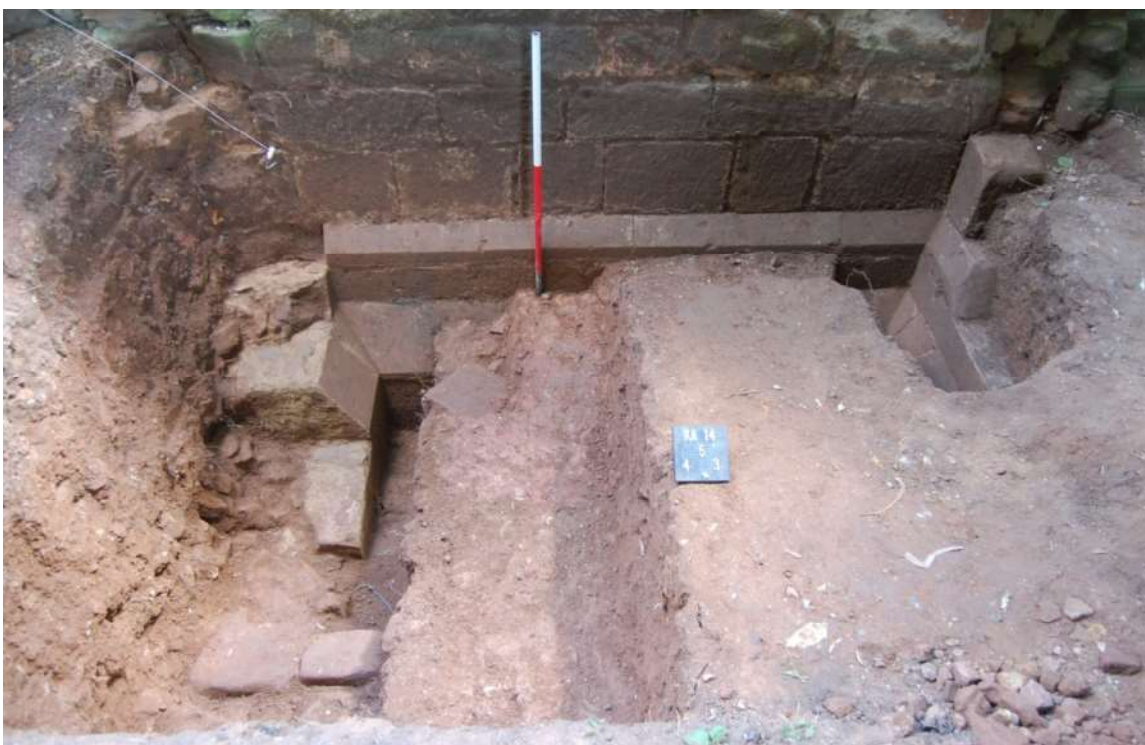
Fig 4: The remains of both probable buttresses and the lower part of the gatehouse wall
