Kenilworth Abbey Fields New Footpath

ARCHAEOLOGICAL MONITORING AND RECORDING

Archaeology Warwickshire Report No 1863
AUGUST 2018

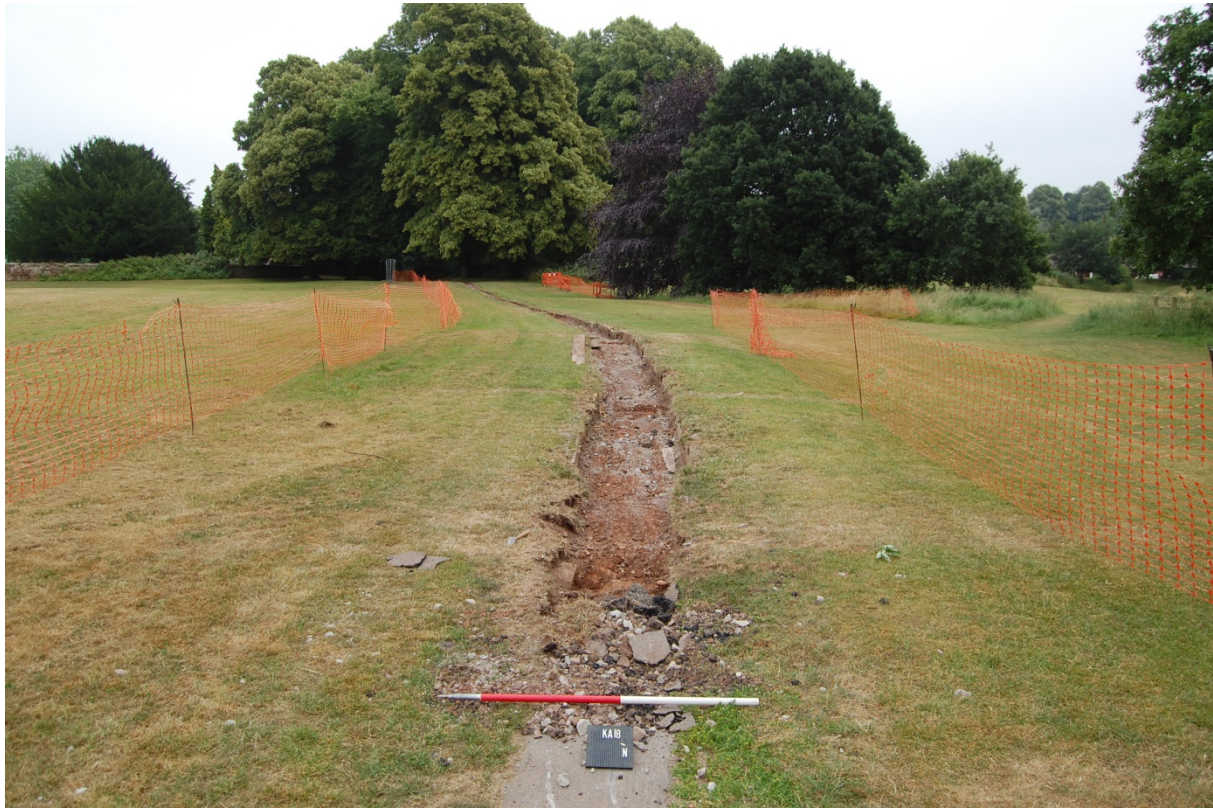
1: Removal of modern tarmac path 100 in progress, looking east

- 4.5 Removal of the existing tarmac path was carried out by a mechanical excavator fitted with a toothed bucket (Photo 1). Subsequent stripping of topsoil and subsoils to the depth required for the new path was then achieved with a wider toothless ditching bucket (Photos 2, 3 and 4). The trench for the new path was generally 1.7m wide. Any archaeological features encountered were cleaned by hand and recorded using digital and manual film cameras, and pro-forma recording sheets.

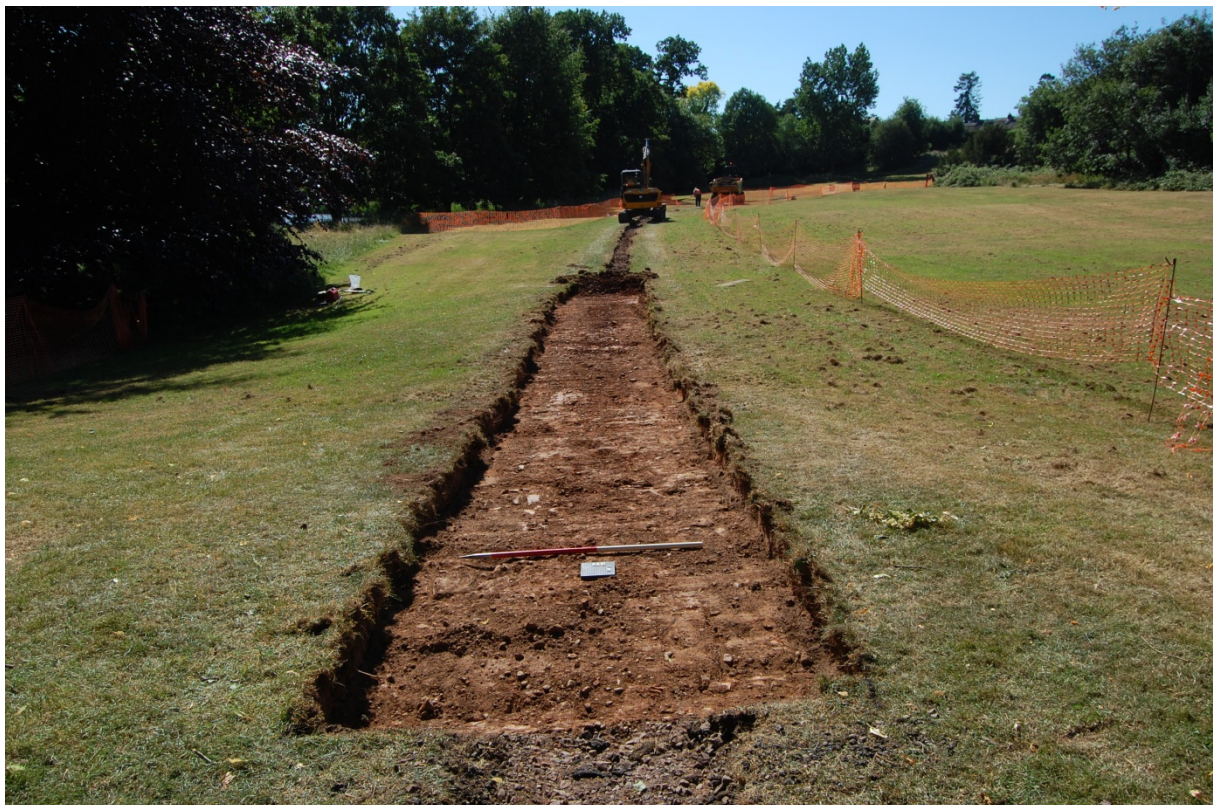
2: Stripping of topsoil and subsoil with a toothless bucket following removal of existing tarmac path

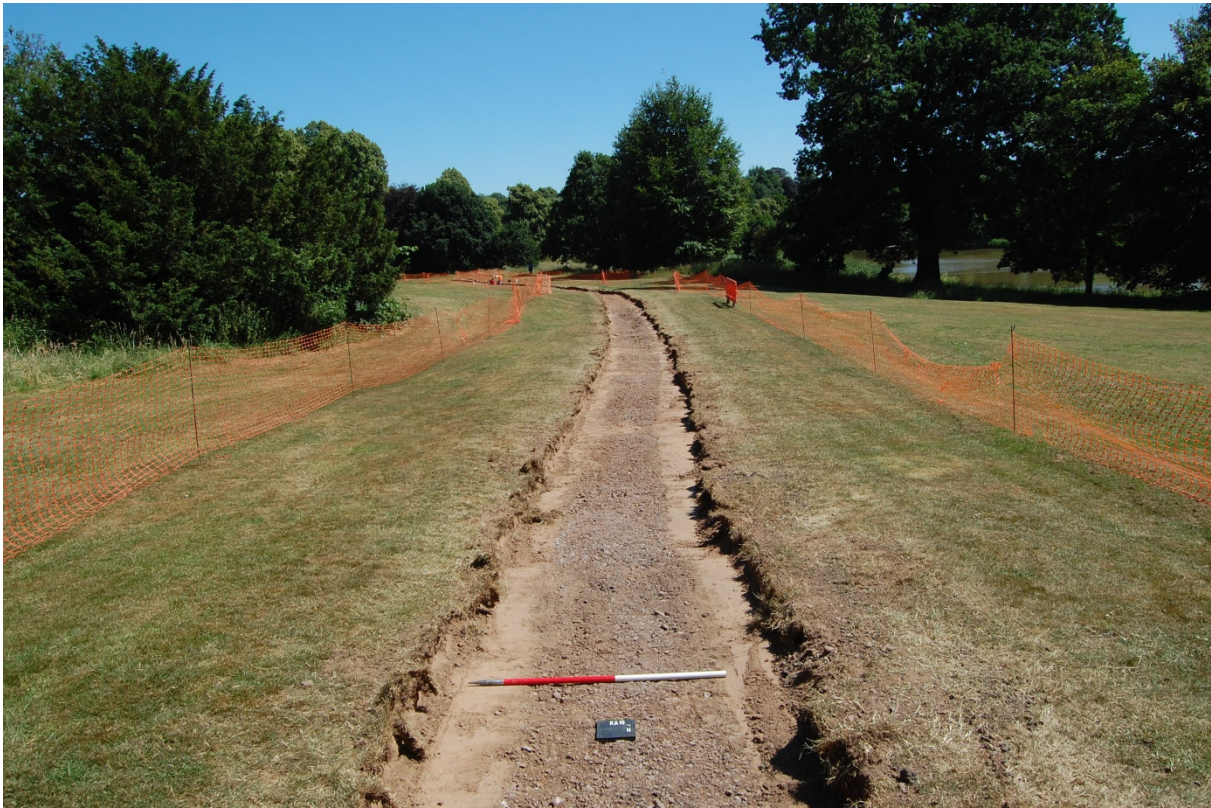
3: Trench for new footpath excavated to a depth of 0.25m with a toothless ditching bucket

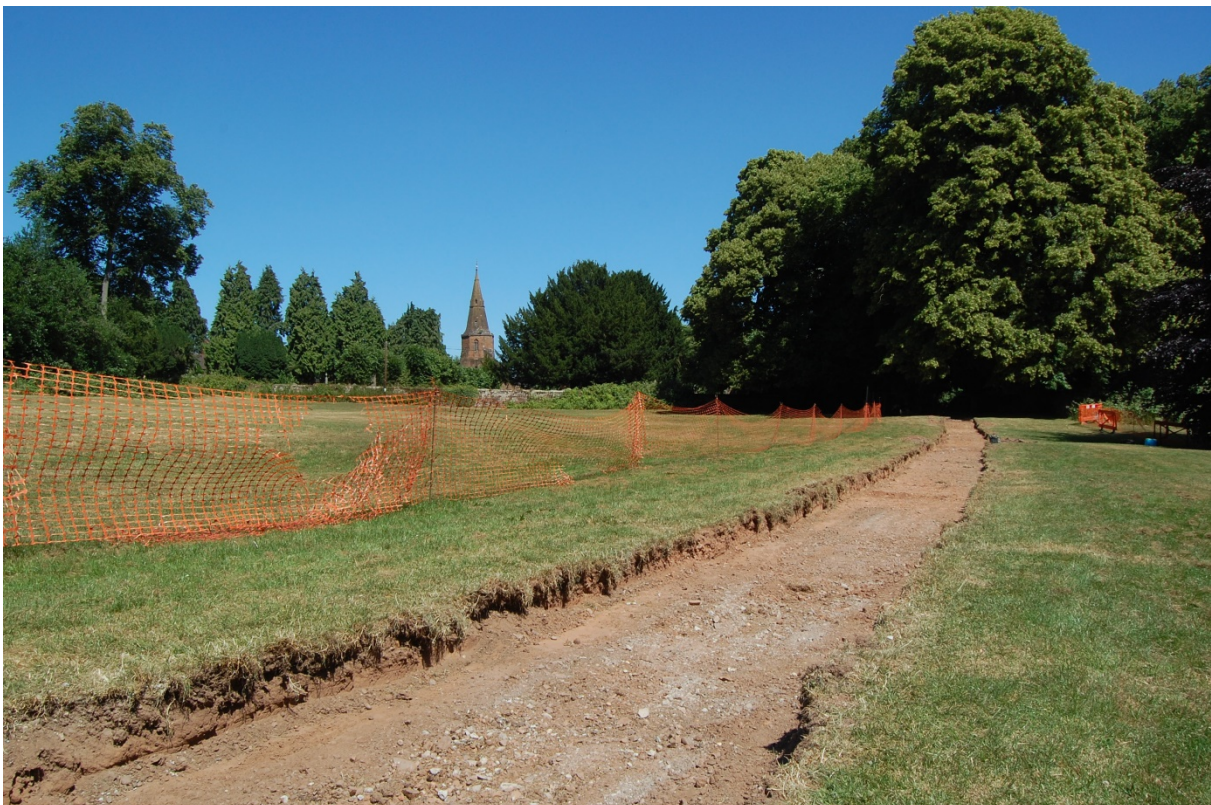
4: The new footpath trench with St Nicholas Church beyond, looking north-east

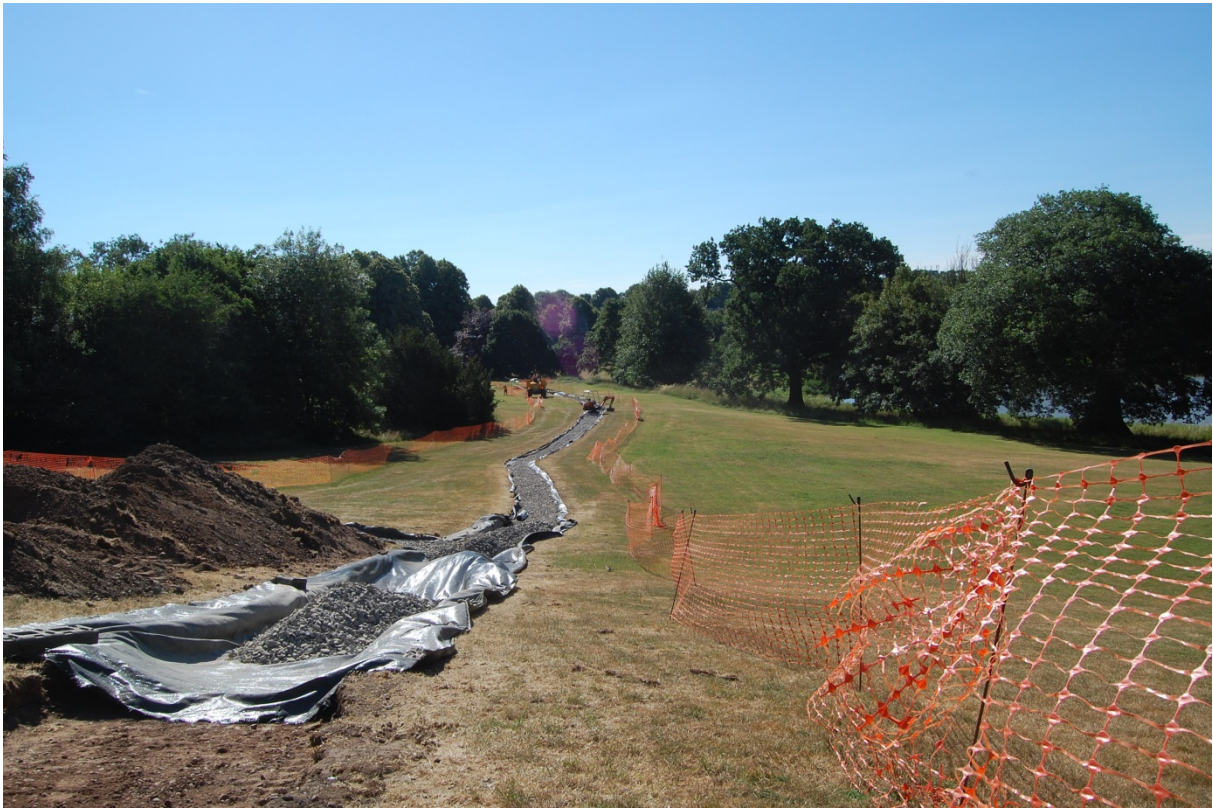
5: Geotextile permeable membrane and base course being positioned following trench excavation and recording of archaeological features. View south-east from top of hill at the site's western end

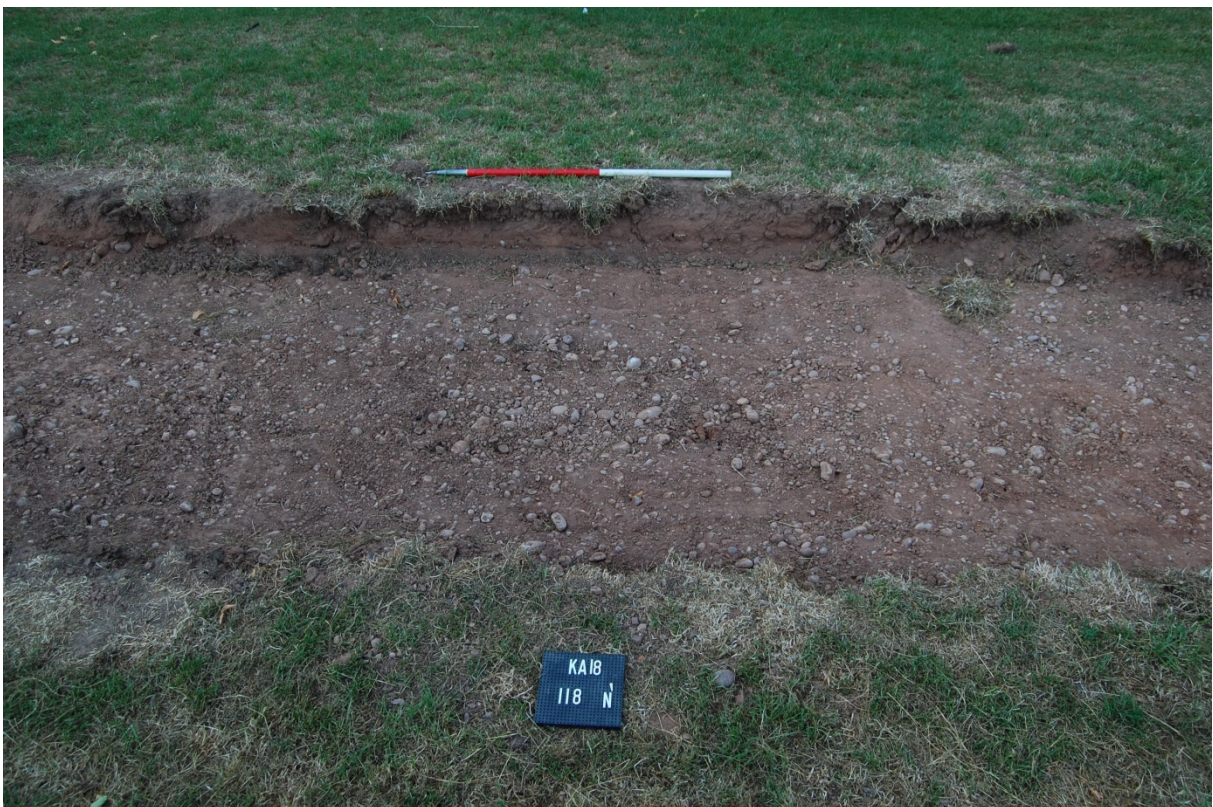
- 5.2 At the trench's eastern end, close to the Gatehouse, a layer (118) of light reddish grey brown sandy silt with frequent small to very small sub-rounded stones was noted (Photo 6) which may either comprise a subsoil, separate to subsoil 106 (see below), or the upper surface of a natural river terrace deposit of sands and gravels as recorded by the British Geological Survey (BGS 2018). Further to the west, at the base of the hill which slopes upwards to the north, a concentration of stone (126) initially thought to comprise a wall was cleaned and re-interpreted as a either a rubble dump or, more probably, an outcropping of natural sandstone bedrock (BGS 2018) (Photo 7). Both deposits were notable for the absence of finds, with the sands and gravels being differentiated from adjacent layers partly because they didn't contain tile and CBM fragments.

6: Possible subsoil or river terrace sand and gravel deposit 118, looking south

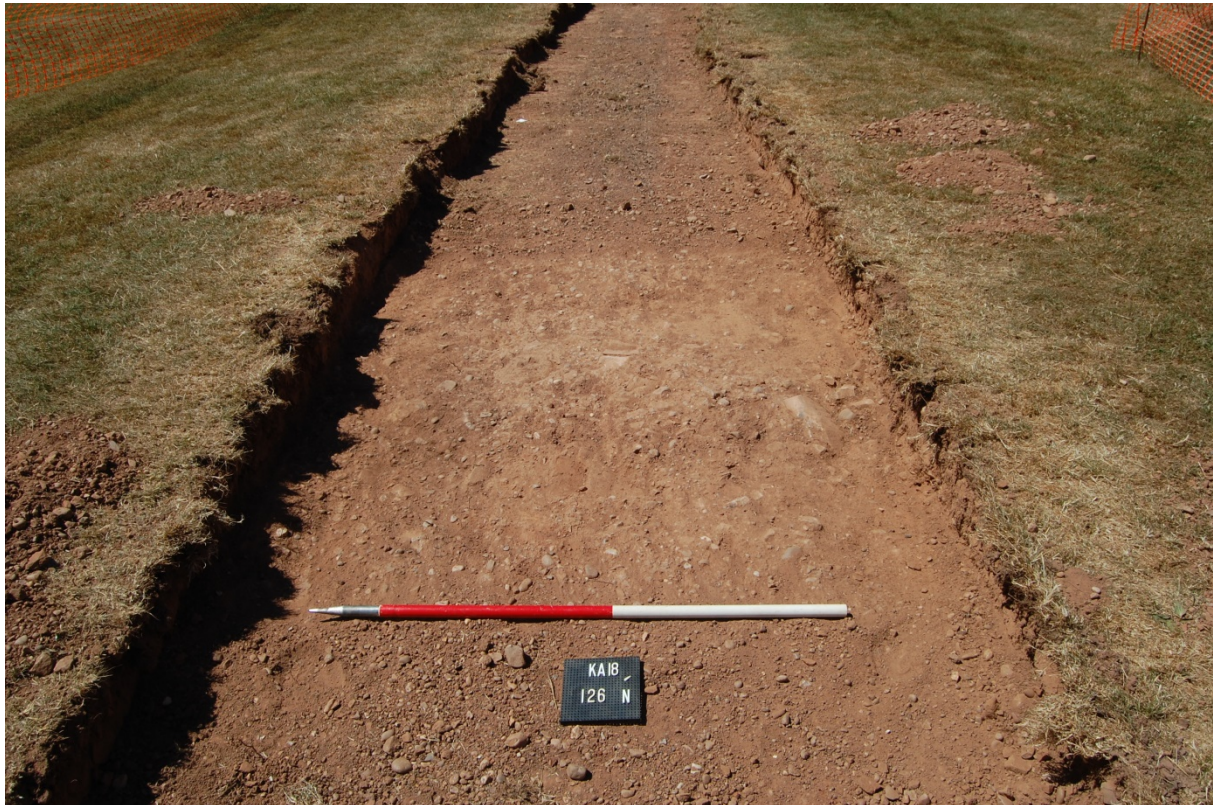
7: Possible natural sandstone outcrop or densely packed rubble dump 126, looking north-west

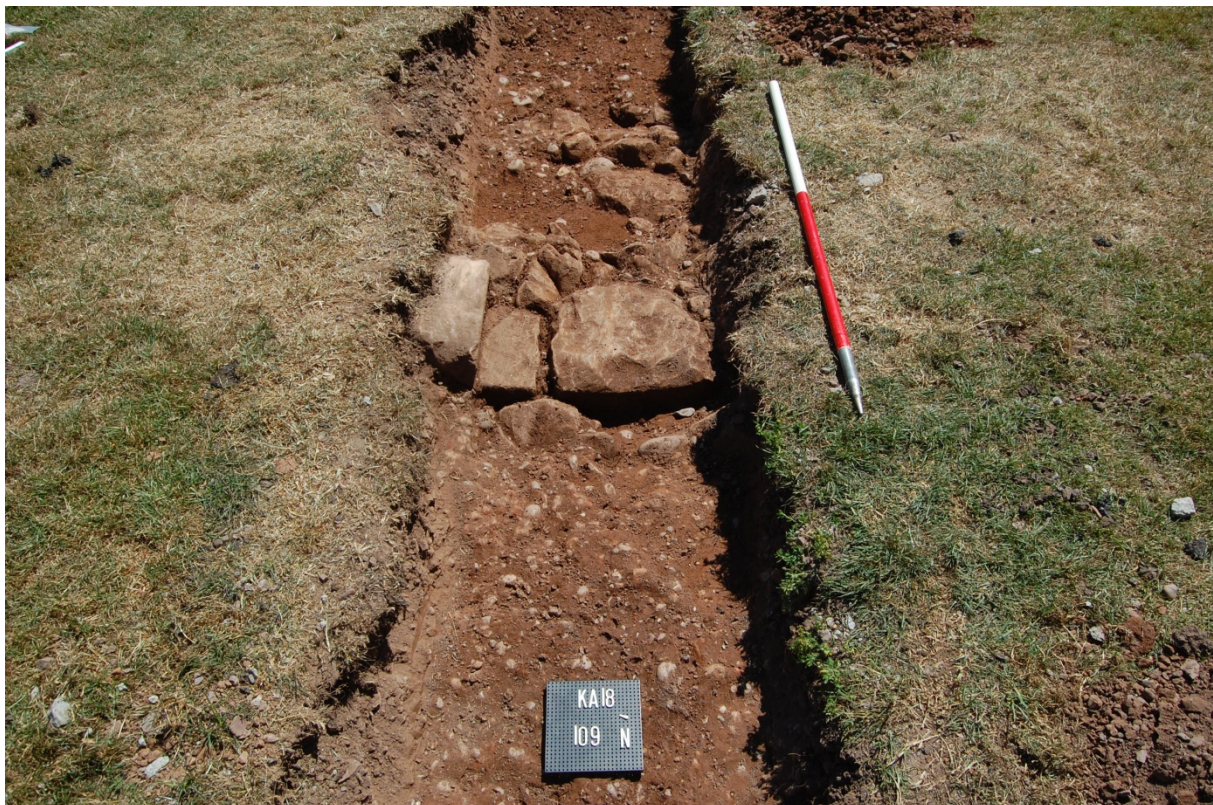
- 5.4 The feature was first identified during removal of the existing tarmac path (100) and underlying gravel foundation layer (103). Preliminary cleaning showed it to most likely comprise a stone wall running NNE-SSW across the trench (Photo 8). This was confirmed when, to accommodate the new path's width, the trench was carefully widened and deepened with a toothless ditching bucket under close archaeological supervision (Photo 9). The orientation of the wall does not match that of the buildings to the east in the main precinct, but may have been related to the lie of the land and location of the former pool's northern side. The wall was found to sit within a linear

8: Wall 109, looking north-west following its initial discovery and prior to trench widening with a toothless bucket

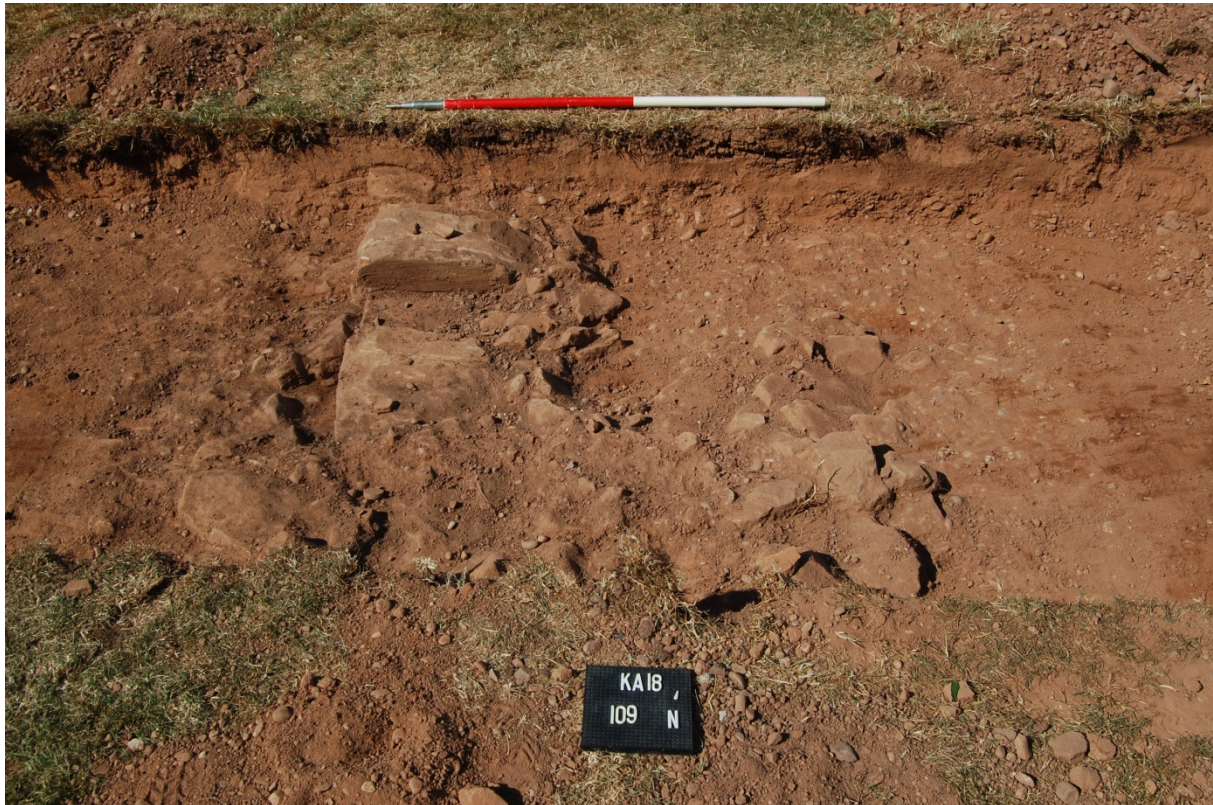
9: Wall 109, looking north, following trench widening but prior to excavation of wall faces

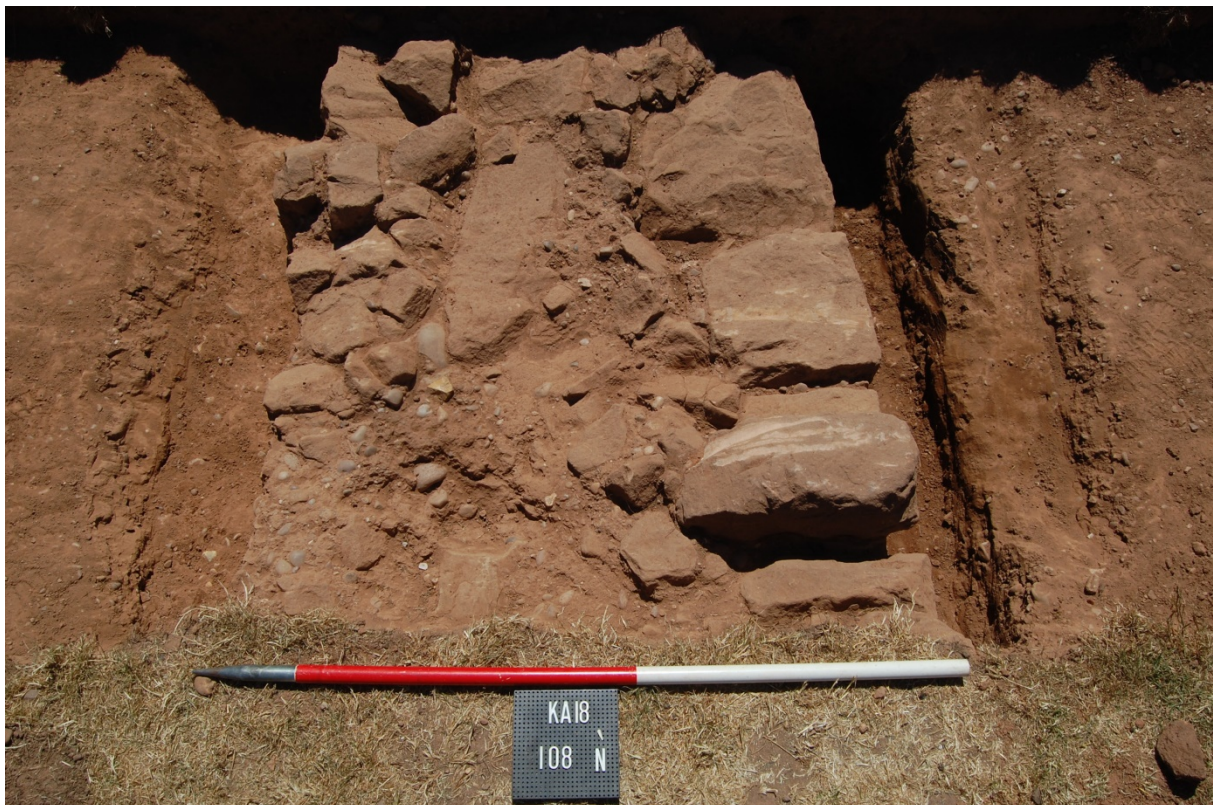
construction cut (108), filled by dark reddish brown silty clay with moderate inclusions of small sub-angular and sub-rounded stones (129). Much of the structure was obscured by rubble (110) comprising brown sandy loam and frequent small to medium-sized fragments of stone (Photo 10). This deposit, which also yielded a piece of glazed medieval roof finial and an iron nail, is thought to represent the remnants of collapsed wall, mostly derived from the structure's rubble core. The wall's substantial nature was indicated by a large isolated stone with a rounded convex upper surface resting atop a larger dressed sandstone block on its western side. Removal of the rubble revealed a well-built footing 0.9m wide and 0.46m high with clearly defined eastern and western faces made up of a single course of dressed sandstone blocks (Photos 11, 12 and 13), which retained a thin rubble core. Excavation demonstrated that no further courses existed beneath the blocks, meaning the exposed structure comprised the lowermost part of a wall foundation. No floor surface was recorded in association with the footing, which was, in any case, likely to have been below ground level when it was standing.

10: Wall 109 within construction cut 108, looking south, with rubble layer 110 still obscuring much of the eastern facing stones

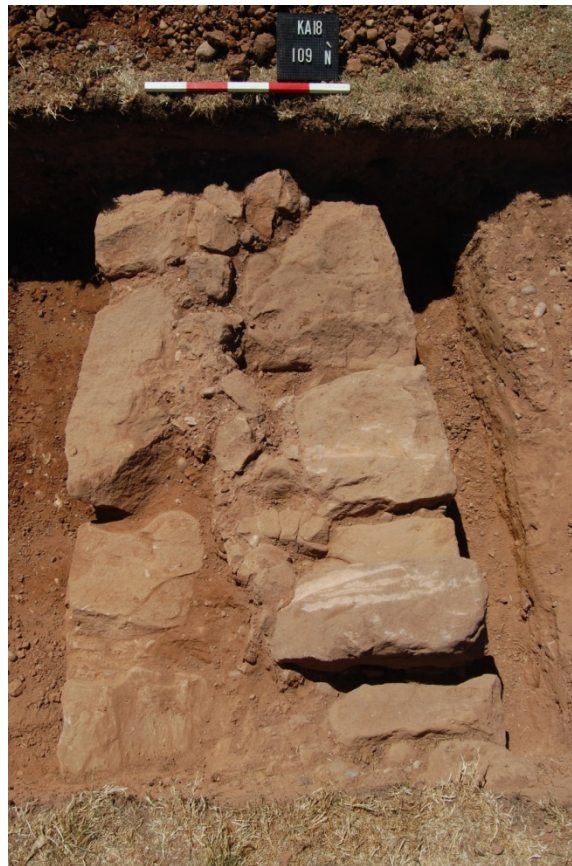
11: Wall 109, looking south-west, following removal of rubble layer 110

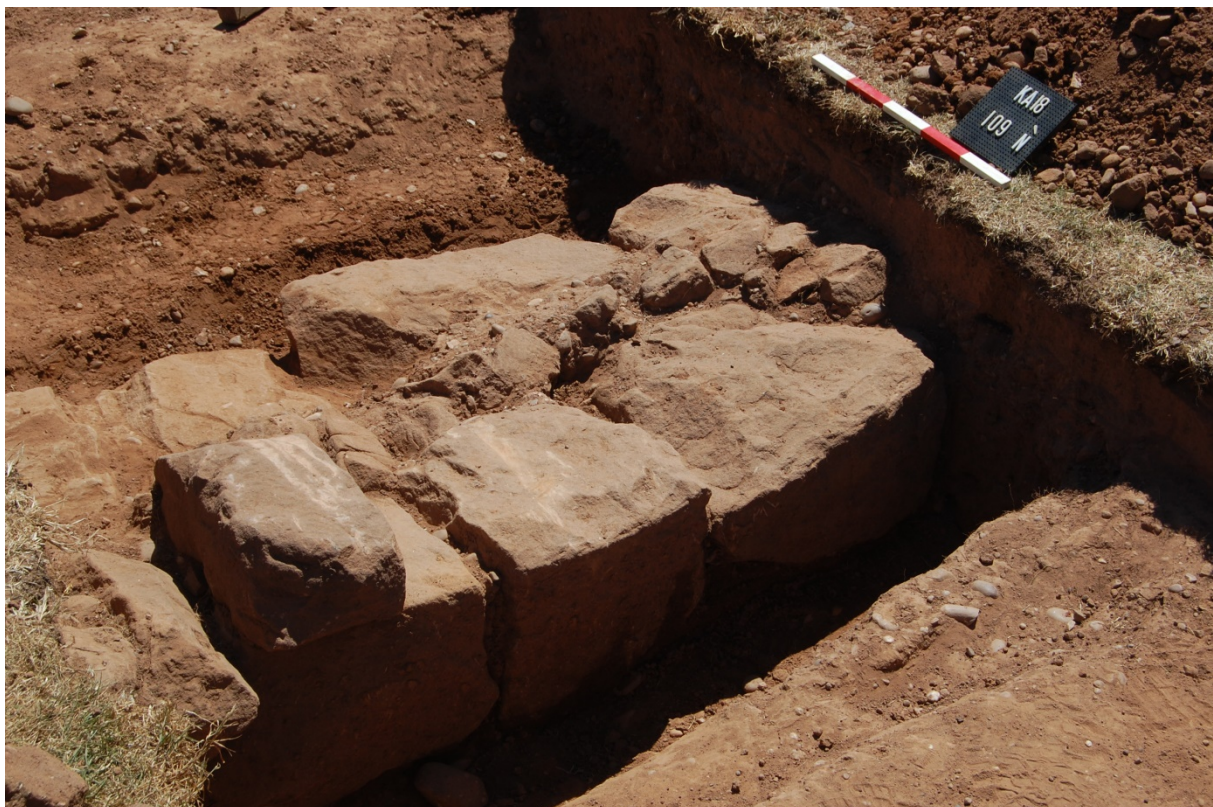
- 6.4 The largest and most significant feature encountered during the watching brief was wall 109. With well-dressed, large sandstone blocks forming clear outer faces, the wall is substantial, notably contrasting with the narrower and more crudely built walls recorded in 1989. Few artefacts were found in association with the wall, however, of

those few, a medieval glazed roof finial in the rubble layer overlying the dressed stones implies a probable medieval date, as does the wall's size and construction.

12: Wall 109, looking south, showing the lowermost foundation course of dressed sandstone blocks

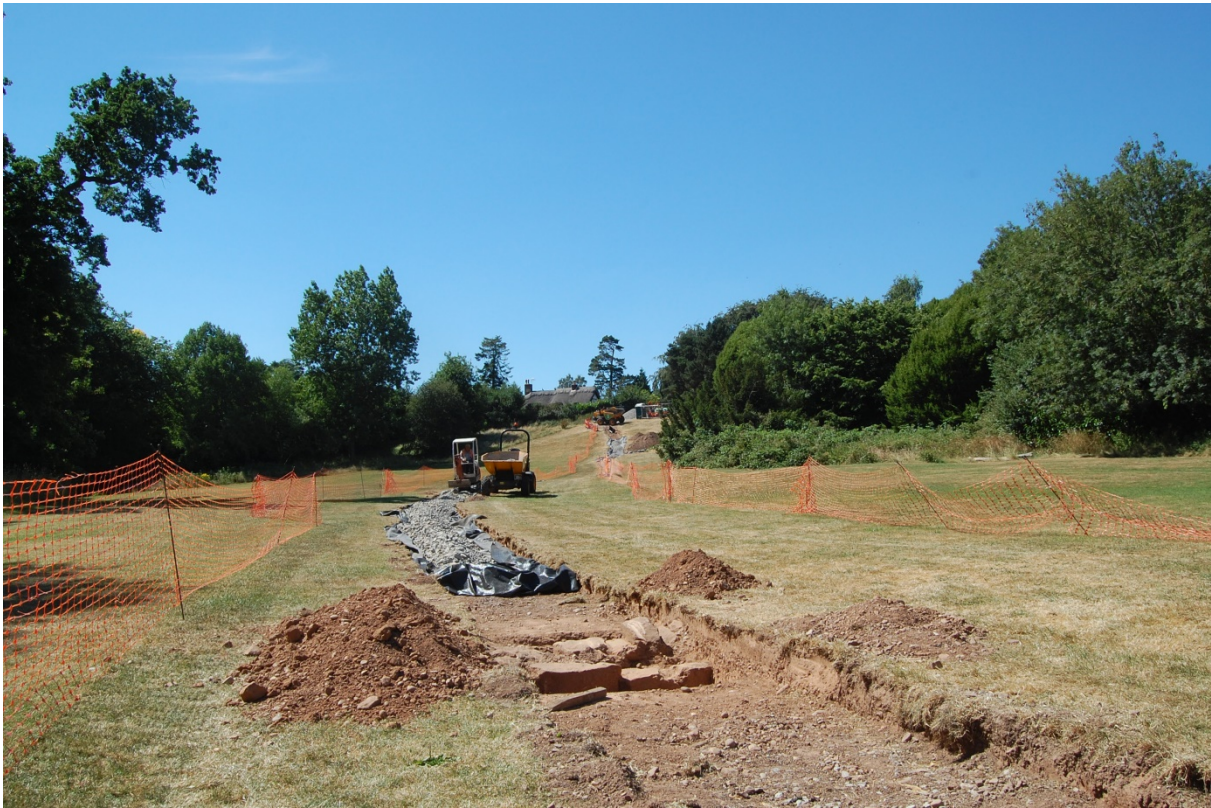
13: North-west-facing view of site with wall 109 in the foreground and positioning of foundation material for new path in progress beyond

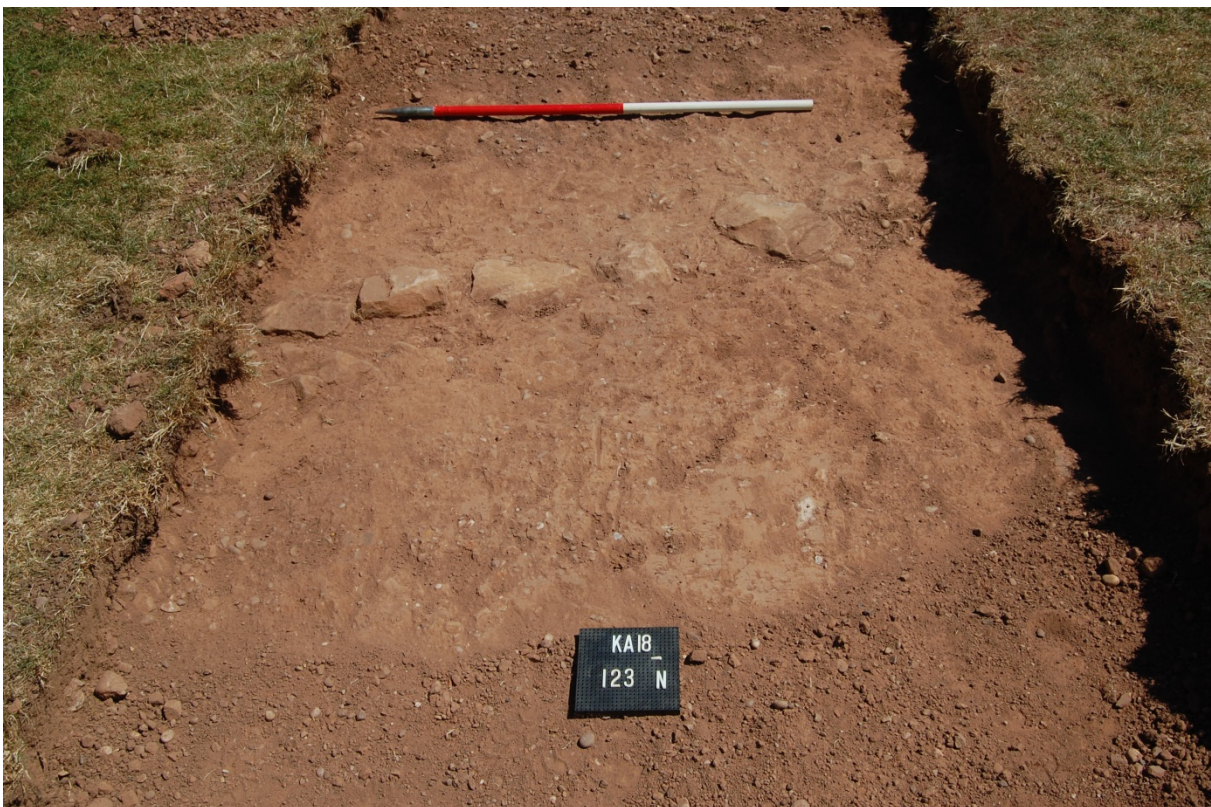
- 5.5 West of the wall a narrow, linear structural feature (123) was also encountered extending roughly N-S across the trench for the new path (Photo 14). This took the form of a line of rough stone pieces, at least 1m long and 0.15–0.25m wide, not obviously worked or dressed and with significant gaps between each stone. These sat within a construction cut (122) clearly visible in plan but not excavated as the feature was positioned at the contractor's required depth. The structure may comprise the footing for a poorly built wall or, more probably, a drain with the sandstone pieces forming capping stones.

14: Possible stone drain 123, looking east

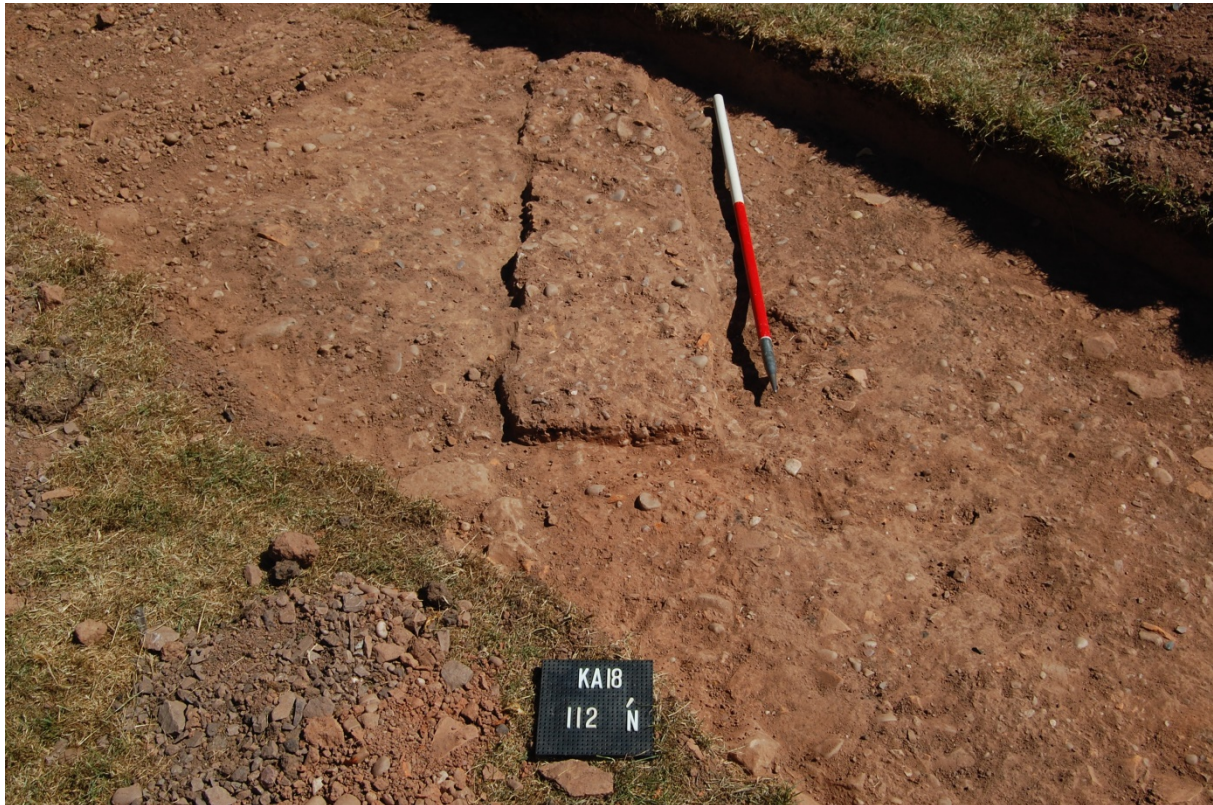
- 5.6 At the trench's eastern end, close to an area of trees and the churchyard of St Nicholas, a possible wall footing was recorded oriented NNW-SSE across the trench's full width (Photo 15), 0.4m wide and at least 2.3m long, the feature was first revealed as a linear area of hard-packed light reddish brown clay, with inclusions of frequent sub-rounded, angular and sub-angular stones, and moderate tile/CBM fragments, contrasting with surrounding subsoil 106. Twelve tile fragments were recovered, representing roof and floor tiles of probable medieval date, in addition to a single, very small fragment of burnt bone (not retained). Removal of the subsoil showed the clay to be upstanding but also likely extending deeper into the ground indicating it was structural rather than simply the fill of a ditch or gully. This was demonstrated more clearly by excavation of a slot through the feature to the depth of

the rest of the trench, which revealed the feature in plan, including an associated linear construction cut (111). The wall footing appeared, therefore, to cut through surrounding deposits, including a layer of probable demolition rubble (114) composed of dark reddish brown silty sandy clay with frequent small- to medium-sized stone, moderate tile fragments and moderate coal/charcoal flecks and smears (Photo 16) which was overlain by a thin spread of coal/charcoal, little more than 0.01m thick (105). Consequently, the wall footing must post-date the layers of rubble and coal/charcoal, potentially suggesting it was built in the post-medieval period. Such an interpretation is supported by the apparent re-use of medieval tiles as construction material for the wall footing, many of which closely resemble the tiles retrieved from both the rubble spread and the charcoal layer. A number of medium-sized rough sandstone pieces were also identified either side of the wall footing, towards the trench's south-facing section, possibly representing some of the original walling structure.

15: Possible wall footing 112, looking south-east, following excavation of a section across its north-western end

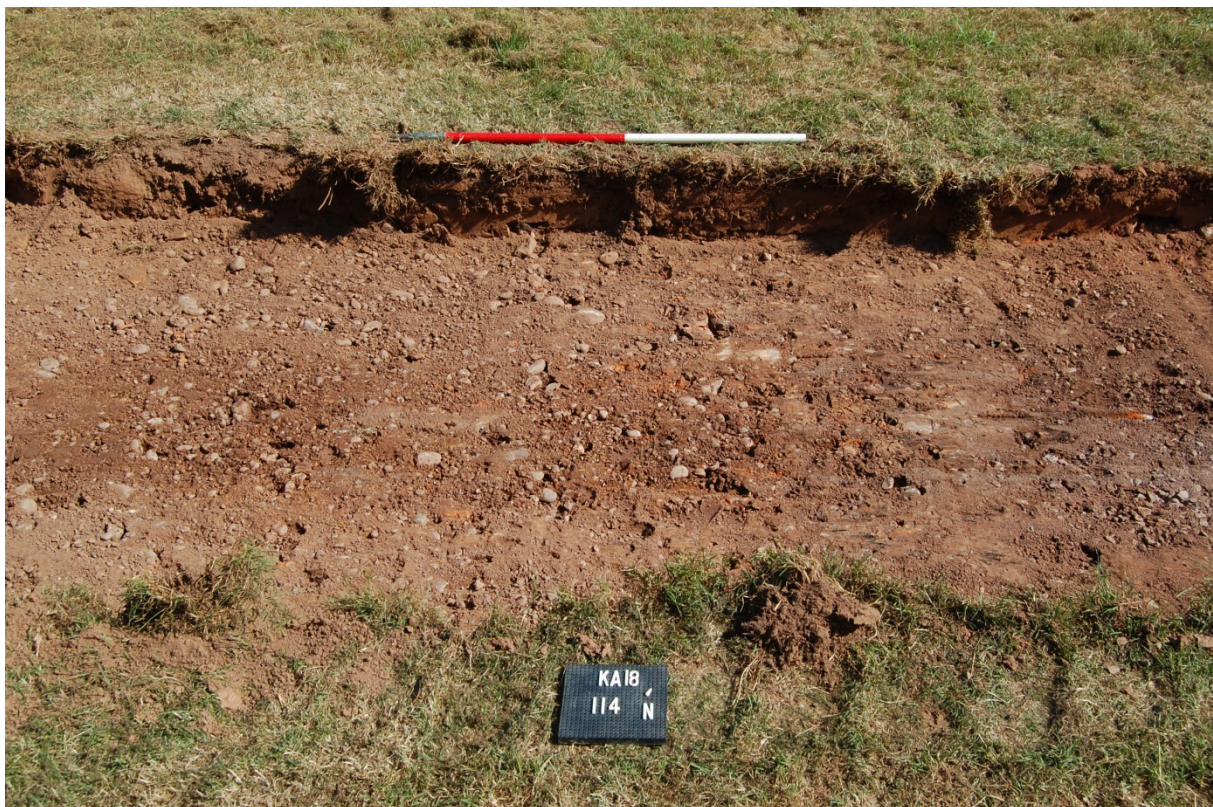
16: Rubble spread/layer 114, looking north-west

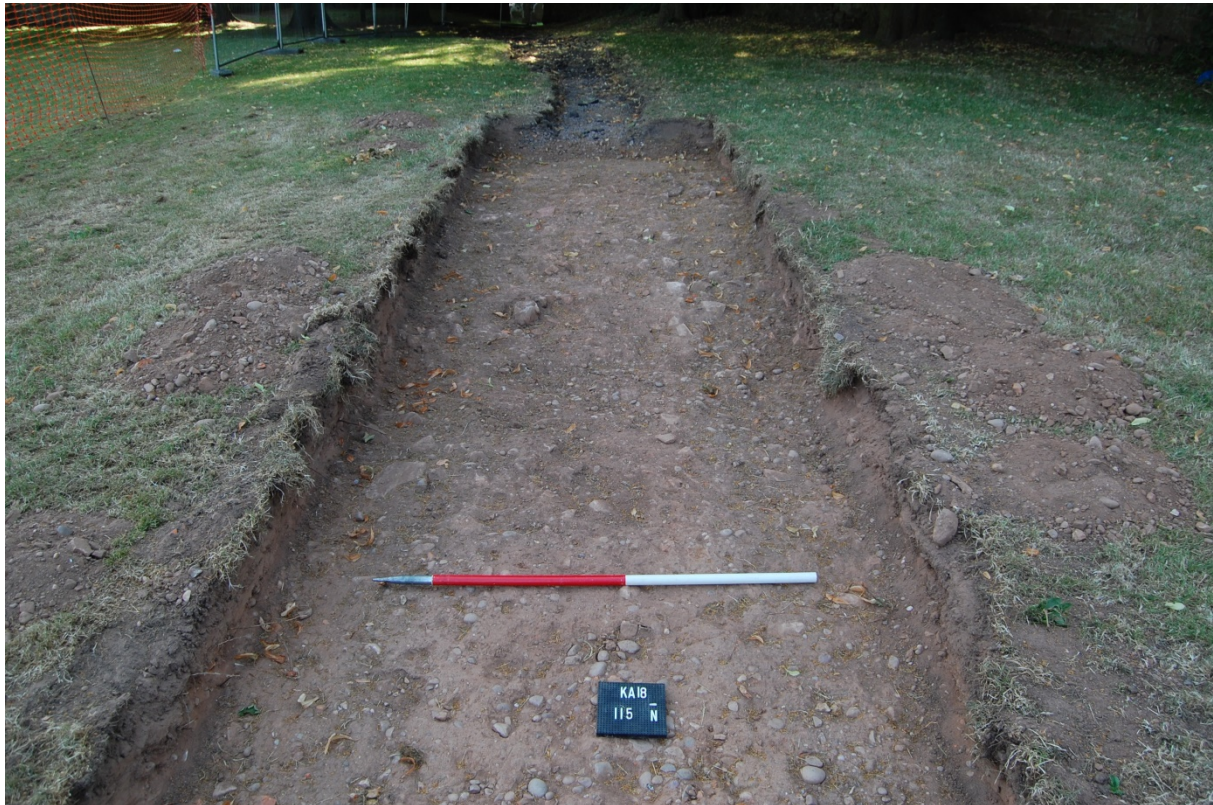
- 5.7 A more substantial area of probable demolition rubble (115) was observed a short distance to the east of the wall footing (Photo 17). Composed of reddish grey brown sandy silt, frequent tile fragments (a sample of 33 pieces were retrieved) and light reddish grey stones, with a single piece of probable glass slag and reddish clay increasing in quantity to the east, the deposit corresponded with an area of raised ground close to the gatehouse. It seems likely, therefore, that the material is the product of the demolition of nearby structures, potentially those associated with the medieval abbey. This interpretation is further supported by the presence of a sherd of Warwickshire Black Ware (RSO1) of 13th/14th-century date within the deposit.

17: Rubble dump 115, looking east

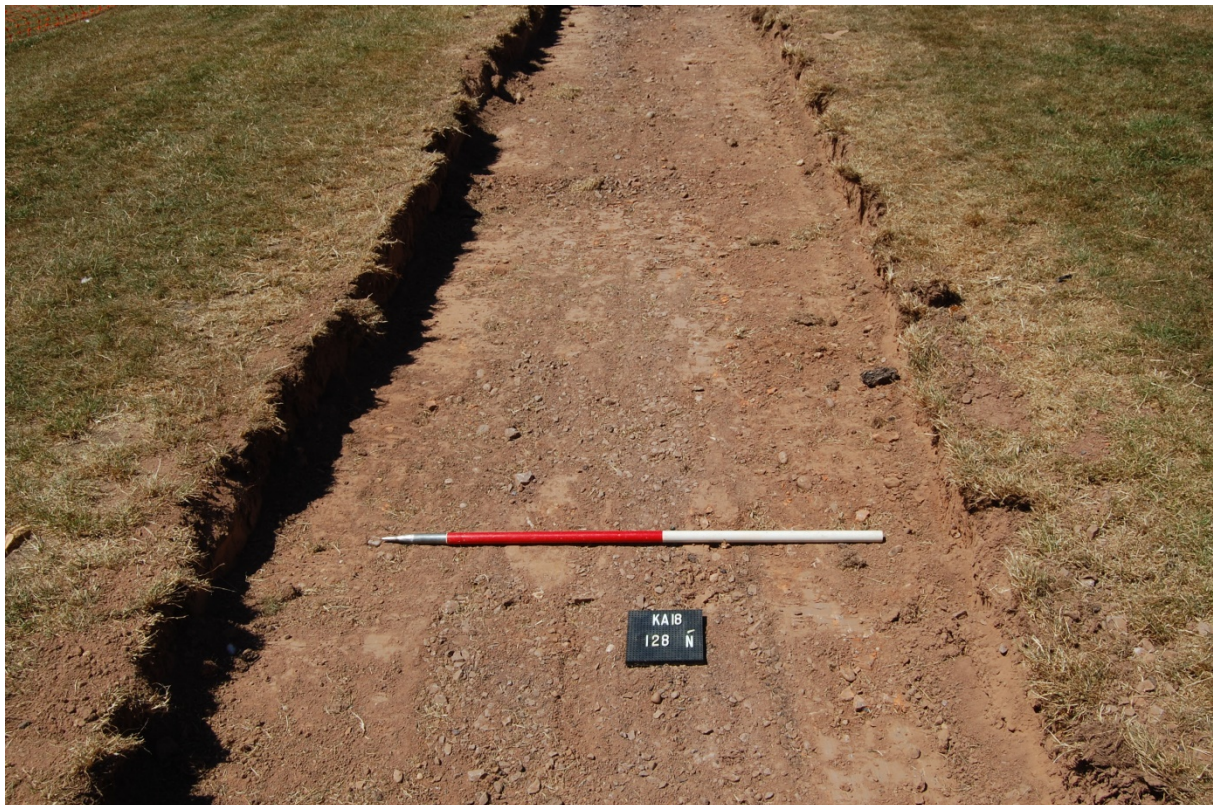
- 5.8 Further west, towards the base of the hill, a spread of tile (128) was also associated with an area of probable made ground (Photo 18). The deposit was primarily composed of light reddish yellow brown sandy silt, with moderate small sub-rounded stones and frequent small sub-angular stones (most likely derived from overlying layer 103 (see below)); however, it also incorporated a conspicuous component of tile fragments, including 11 floor and roof tiles of probable medieval date. Presumably this also comprised a layer of demolition material associated with the destruction of nearby buildings that had been dumped in Abbey Fields. Such a process may provide an explanation for many of the earthworks that can be seen west of the main abbey complex.

18: Tile/rubble spread 128, looking north-west

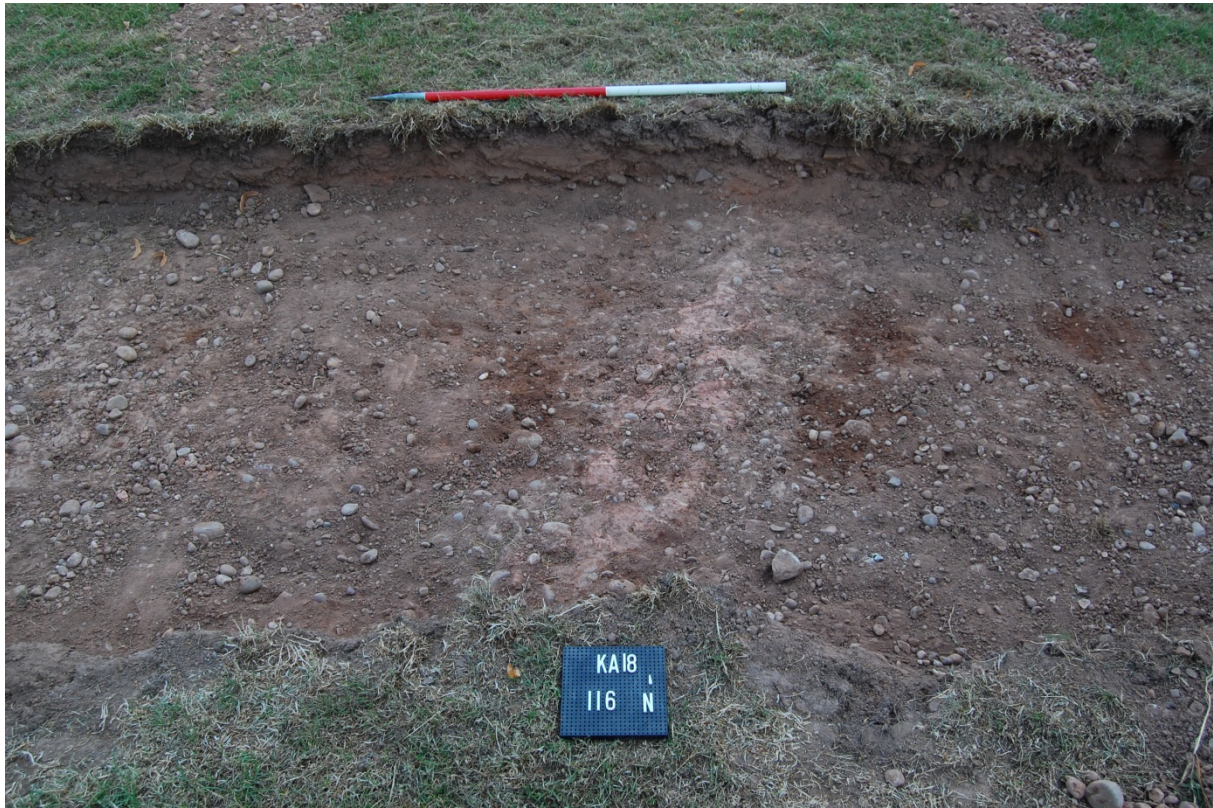
- 5.9 Towards the trench's eastern end a probable modern service trench (116) was observed apparently cutting the subsoil (Photo 19). The feature was 0.25m wide, oriented NE-SW, and filled by brownish red clay with occasional rounded and angular pebbles. As it was observed at the contractor's required depth, and could potentially contain a buried service, the feature was not excavated. A modern plastic land drain was also uncovered further to the west during initial removal of the tarmac path with a toothed bucket (Photo 20). It sat within a rough construction cut and had been sealed beneath a layer of coarse stone/gravel.

19: Modern service trench 116, looking north

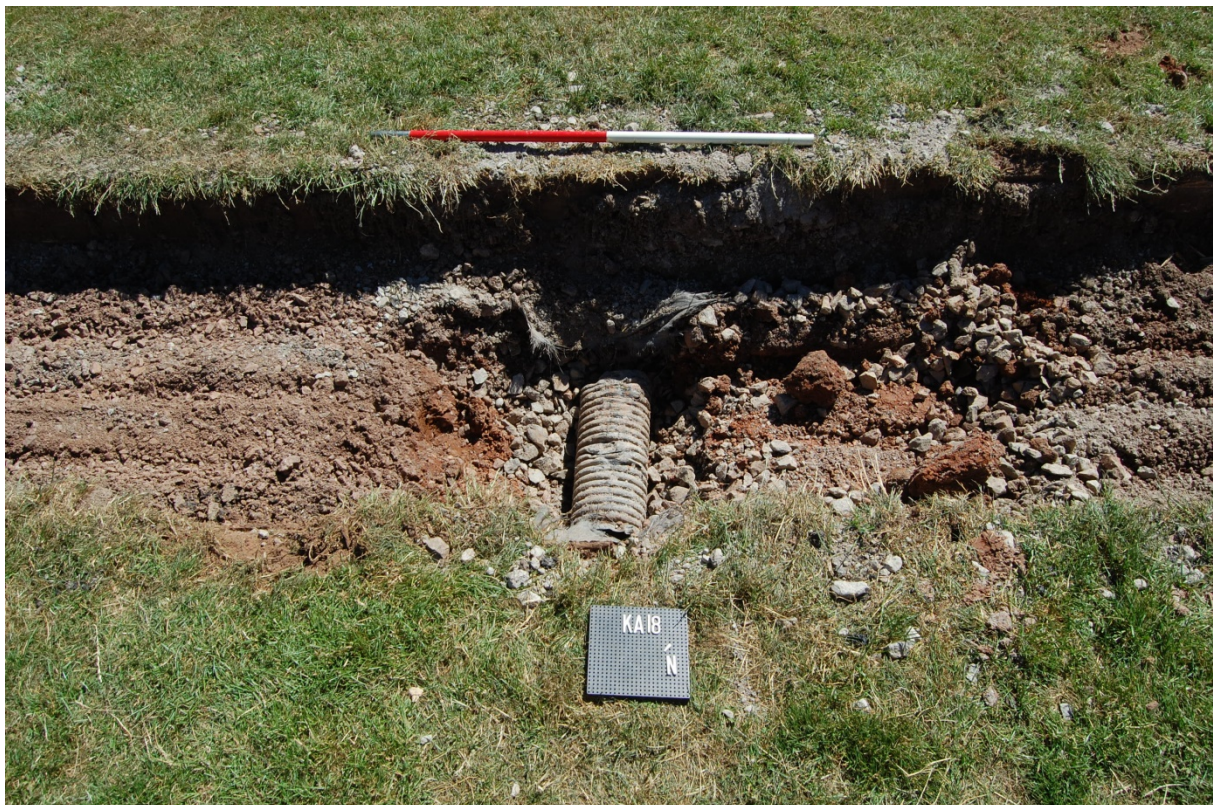
20: Modern plastic land drain revealed in the trench base following removal of modern tarmac path, looking south-east

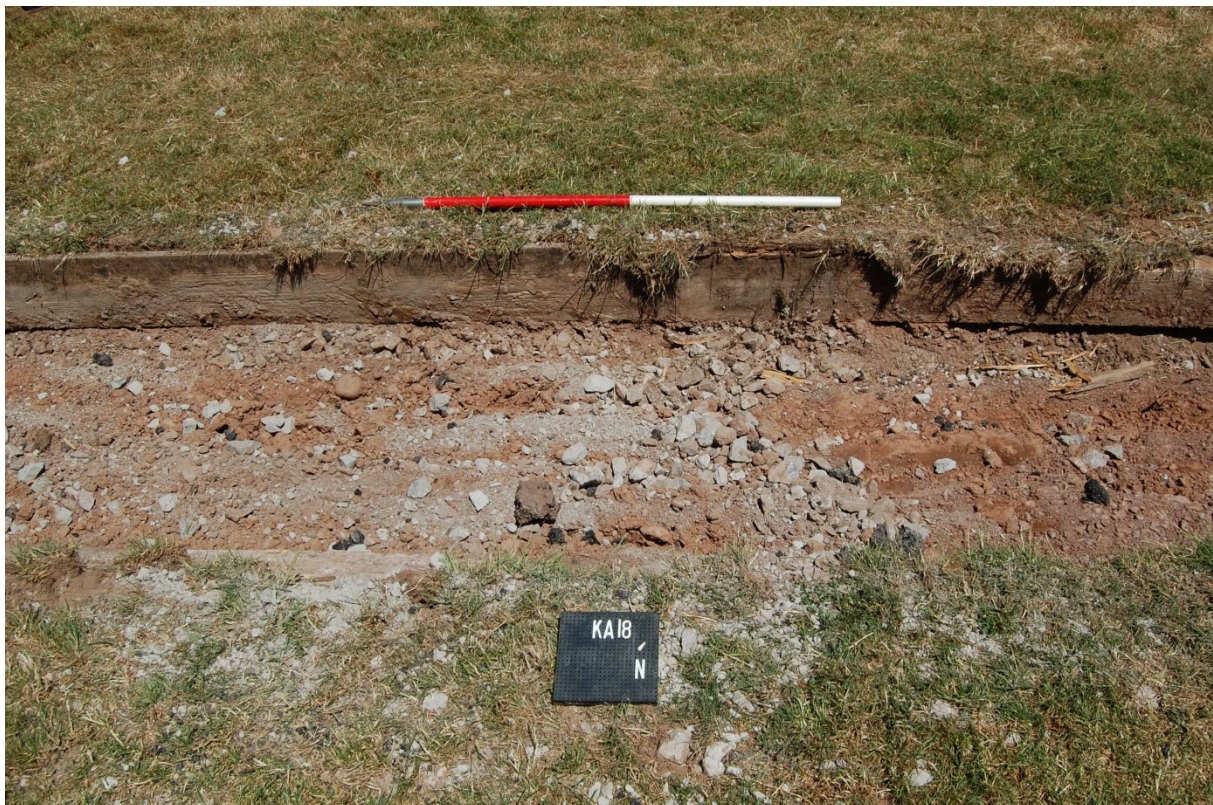
22: Trench for new footpath following removal of modern tarmac, looking north-east, showing the wooden boards either side of the existing path
