# Kenilworth Abbey Fields Car Park, Warwickshire

## Archaeological Watching Brief

Archaeology Warwickshire Report No 1417  
February 2014

**Project:** Abbey Fields Car Park 2013

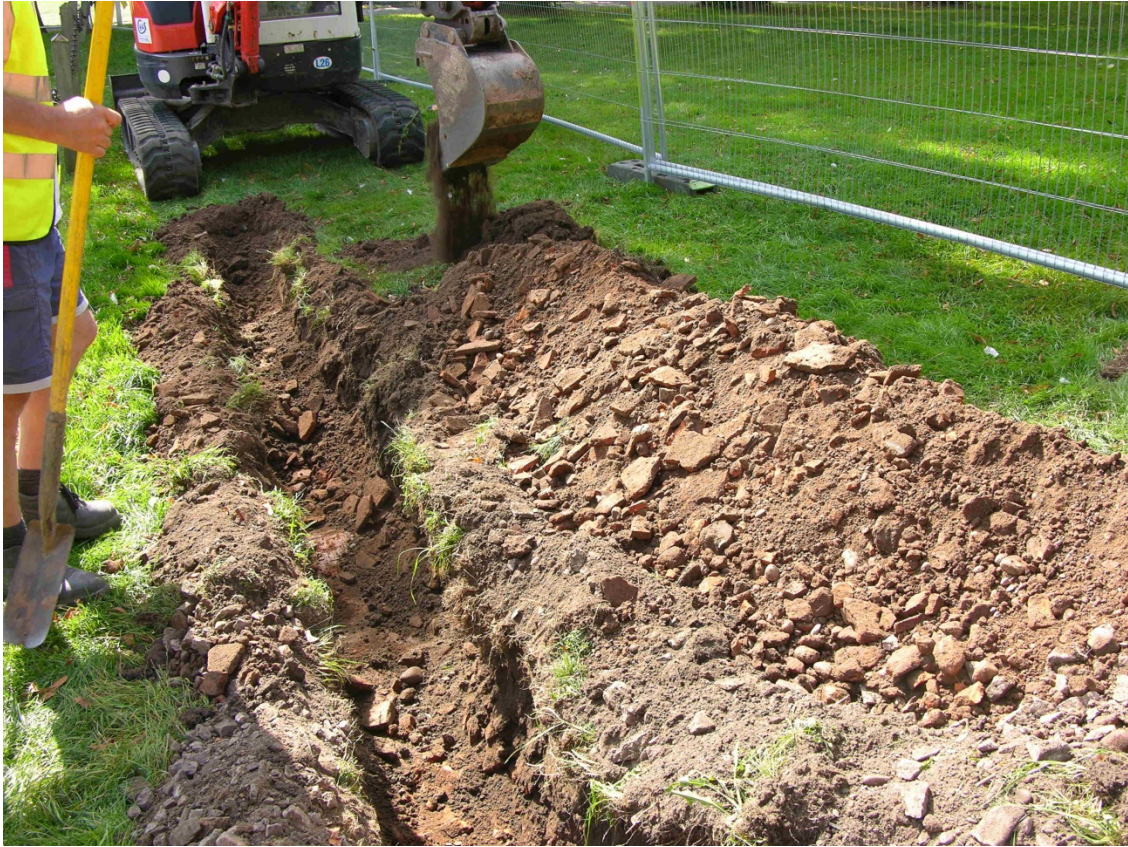
sandy loam (4) overlaid by 0.15-0.20m of topsoil. However, the quantity of roof tile in the lower layer increased markedly towards the west, where it became clear that we were looking at a layer of roof demolition material (9; Fig 3). All this roof tile was hand-made, some had black cores, suggesting it was likely to be medieval. Other finds from layer 4 in the cable trench included a Langerwehe German stoneware pottery tankard base, dating to the 15th/16th century, fragments of medieval floor tile, medieval and post-medieval pottery.

Fig. 3: Excavating through demolition layer 9, on west side of car park

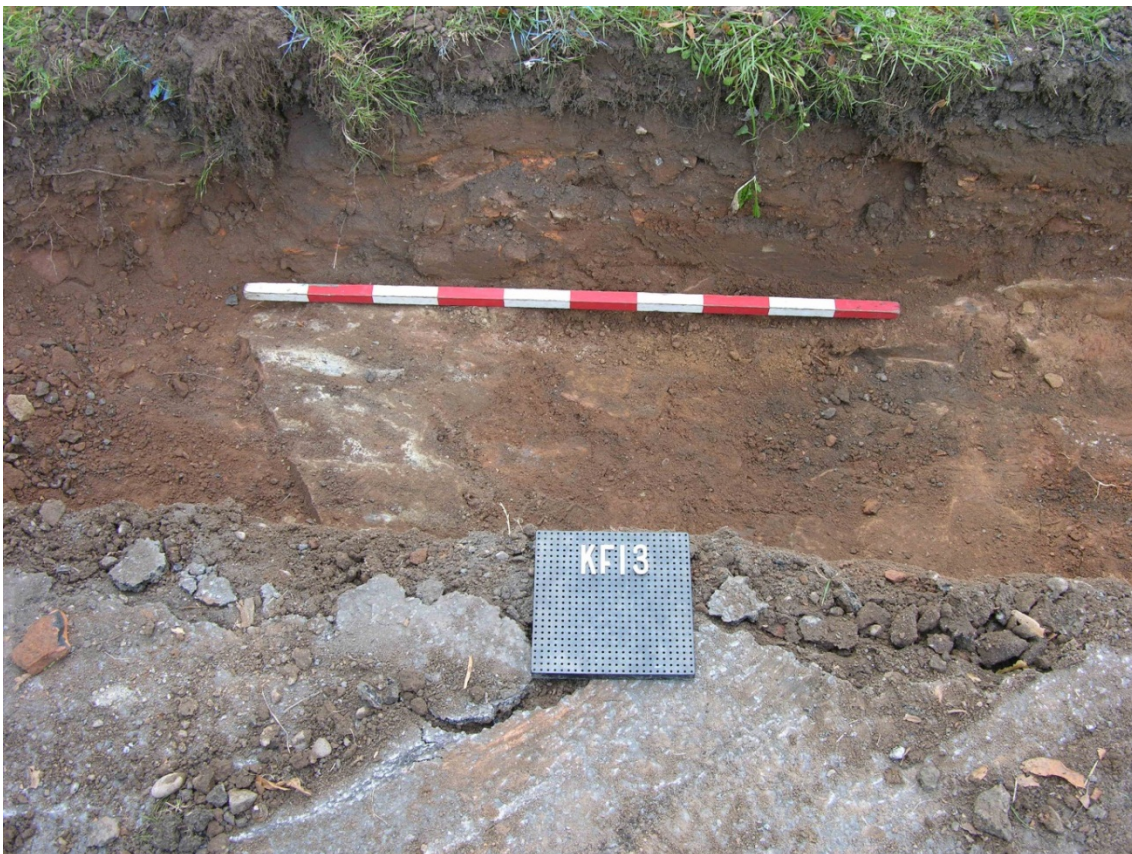
5.8 The stratigraphy was generally similar to that in the cable trench, but the shallower excavation meant that the sandstone walling exposed in the cable trench was not reached. Another substantial sandstone wall (15) was exposed, however, measuring 1.30m across (Fig 4), further south than wall 11. The south edge of the wall was very well-defined while

the north edge was less clear. A significant quantity of sandstone at the southern end of the trench suggested an area of wall demolition.

Fig 4: Wall 15, in western part of site

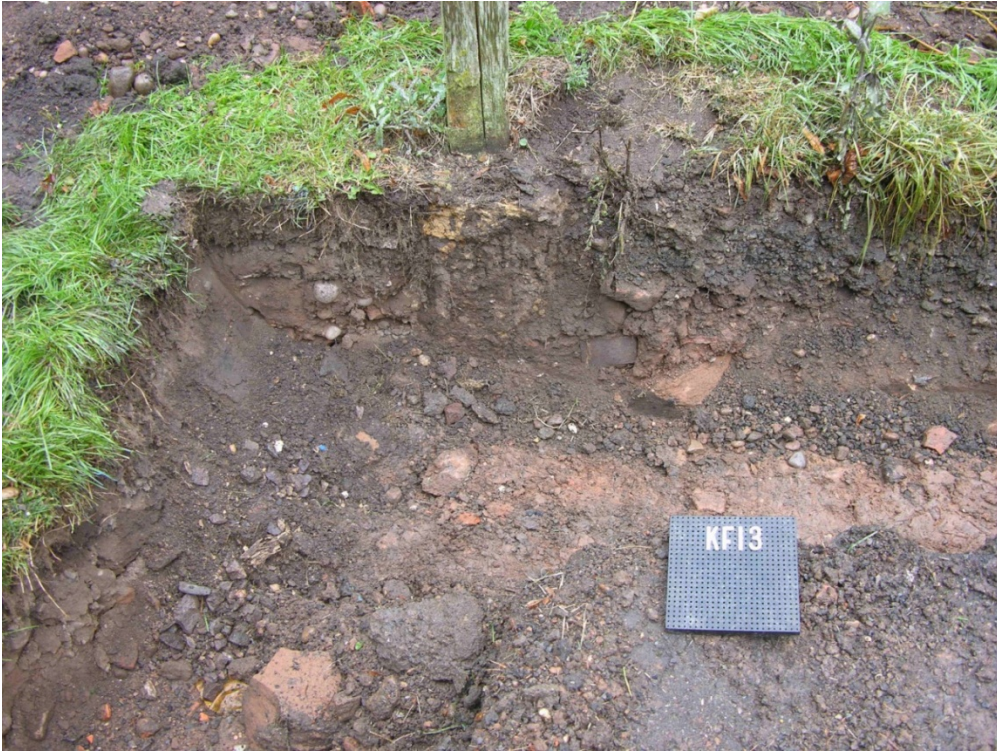
5.5 In the western section of trench the machine scraped over the remains of a sandstone wall (11), roughly 1.20m across, running west-east. To its south was a further 7m of stonework (12) at the trench base, suggesting a length of north-south walling. Another narrower possible cross wall was recorded further to the south (14). The soil overlying 12 and 14, and between them was a dark grey-brown charcoal-flecked loam (13). This, and the reddish brown sandy loam (4) further north was overlaid by 0.10-0.15m of clean brown sandy loam (16), itself overlain by topsoil.

Fig 5: Stonework in north-west corner of cable trench (31)

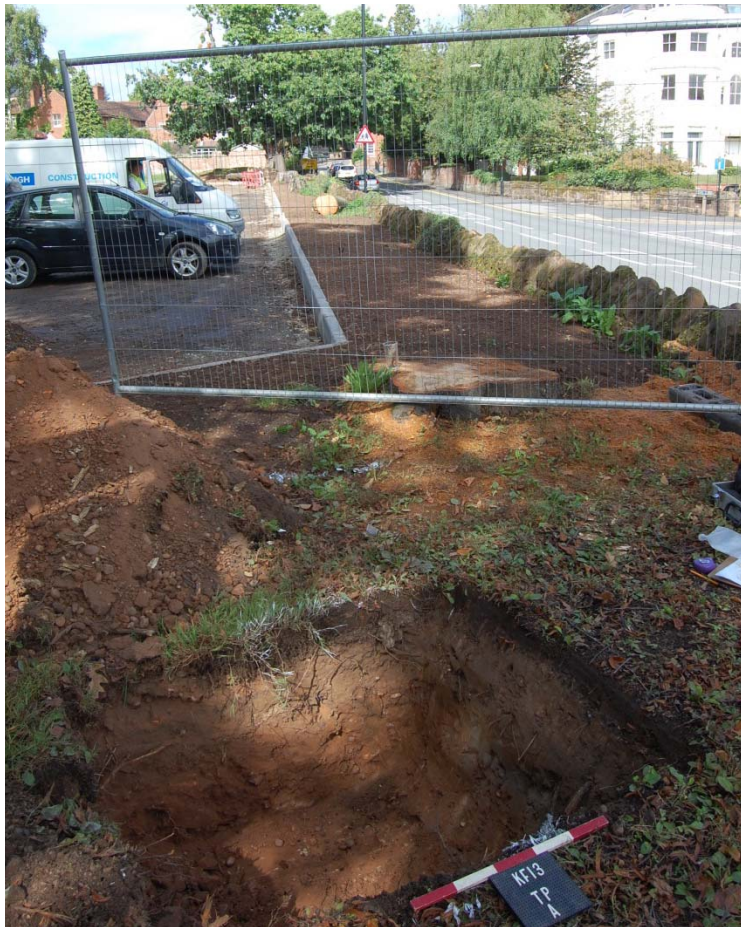
5.11 In order to compensate for the loss of the two lime trees at the car park entrance, two new trees have been planted along the north side of the avenue, where there were previously gaps and a further tree planted at the corner of the car park. The pits for the new trees were 1m square and c.0.76m deep. The sequence in tree-pit A, near the car park entrance (Fig 6), was as follows: 0.38m of reddish brown sandy loam (23) overlain by 0.26m of greyish brown sandy loam (22), itself overlain by 0.12m of topsoil (21). Layer 22 produced a rimsherd of an early 13th-century jug with an applied prunt of clay, with two deep finger impressions, possibly a very crude face mask. The sherd has an under-glaze of white slip, is likely to come from Alcester and is dated to 1200-1225/50 (Ratkai pers. comm.). A similar stratigraphic sequence was recorded for tree-pits B and C, which filled in gaps in the avenue, alongside the path.

Fig 6: Excavation of tree-pit A
