# Abbey Fields Play Area, Kenilworth, Warwickshire

## Archaeological Watching Brief

Archaeology Warwickshire Report No 1353  
September 2013

**Project:** Abbey Fields Play Area

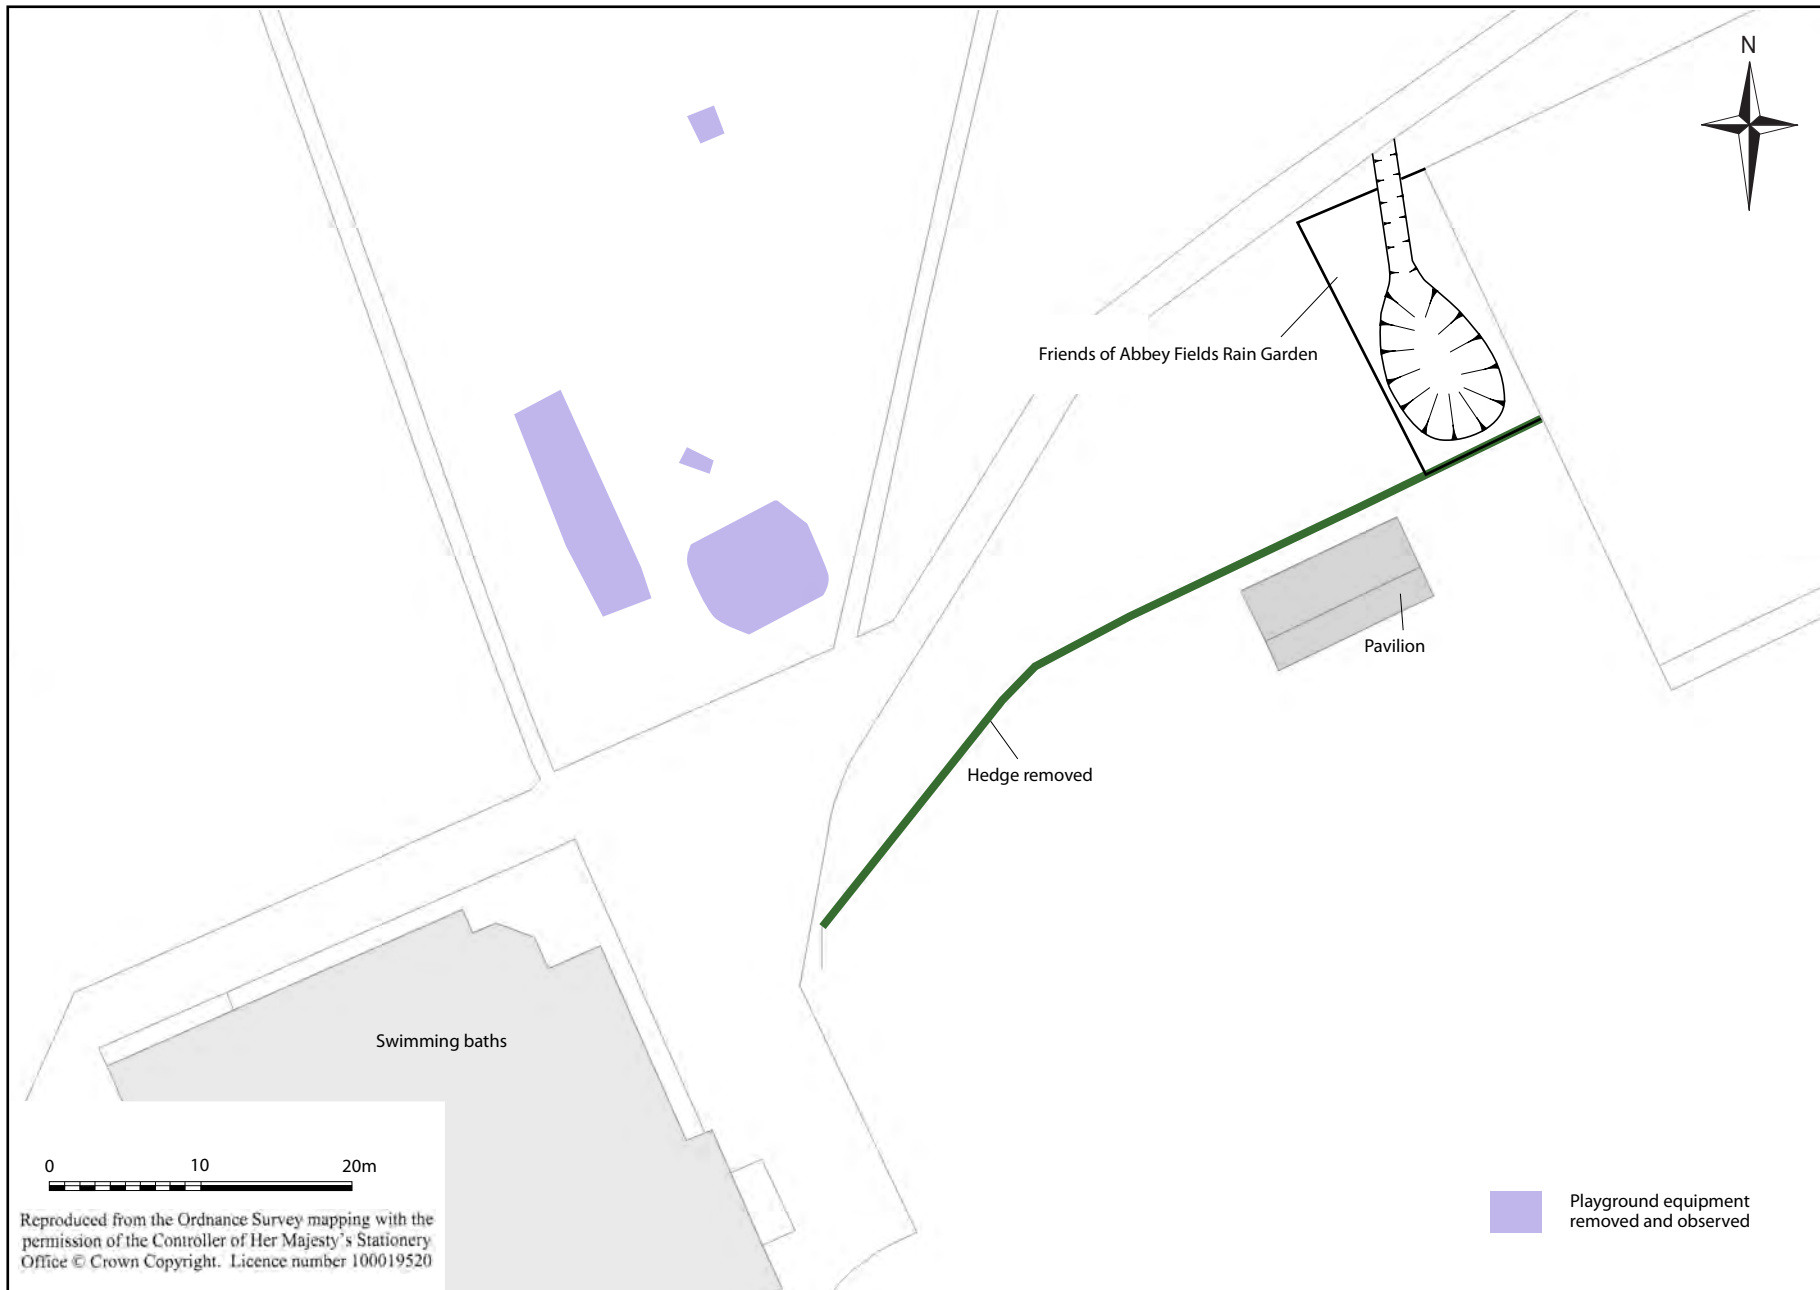
Fig 2: Areas and trenches observed

5.2 Play equipment was removed under archaeological supervision in four discrete areas (Figs 2 and 4). The maximum depth of excavations was 0.4m which exposed only topsoil (1). Removal of smaller elements of play equipment left no discernible holes. The wooden climbing frame was dismantled and no excavation was necessary for this.

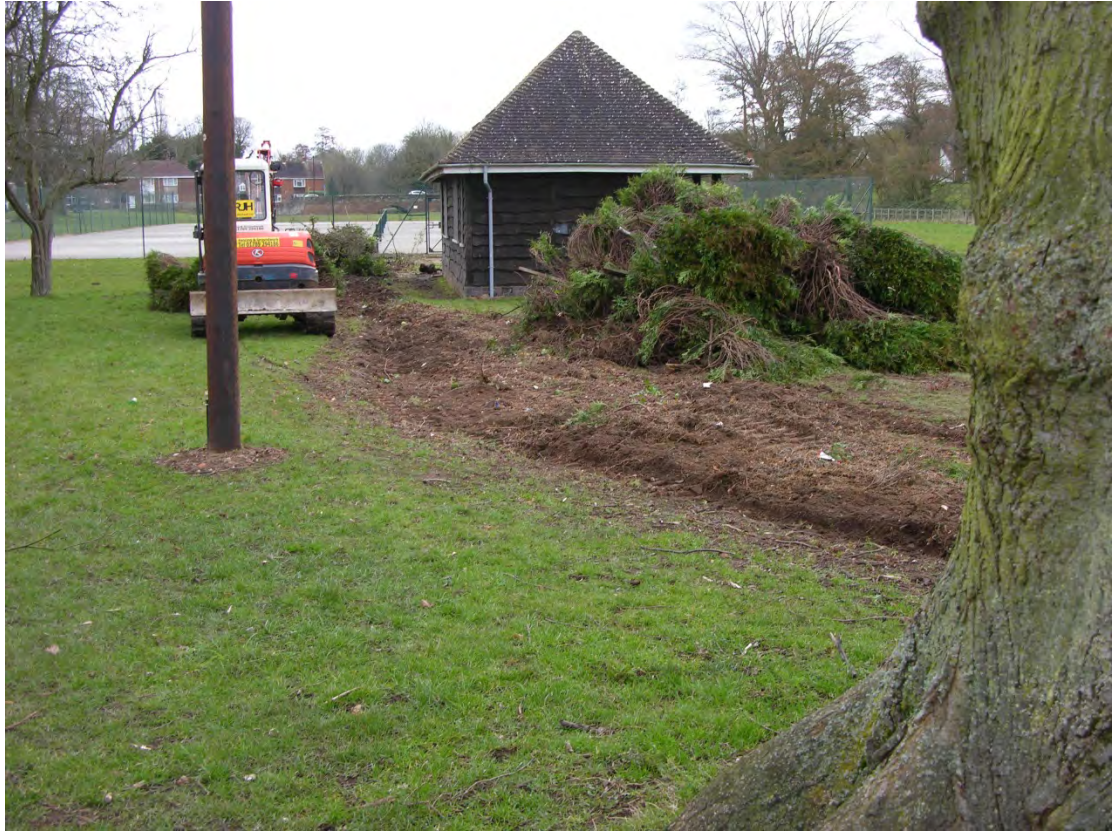
Fig 3: Hedge removal

5.1 A hedge, *c.*1.6m wide and *c.*1.6m high to the east of the swimming pool was initially removed using a mini JCB (Figs 2 and 3). A discontinuous layer of reddish-brown, sandy clay (2) was observed at a depth of 0.3m. Overlying this layer was very dark greyish-brown sandy loam topsoil (1), which large quantities of hand-made roof tile and fragments of sandstone, suggesting we were in an area of medieval demolition. Large quantities of modern rubbish, bottles etc, were also noted during the observation. An area of gravel (3) was recorded at the eastern end of the hedge area, near the tennis courts, suggesting that this had been laid to facilitate drainage.

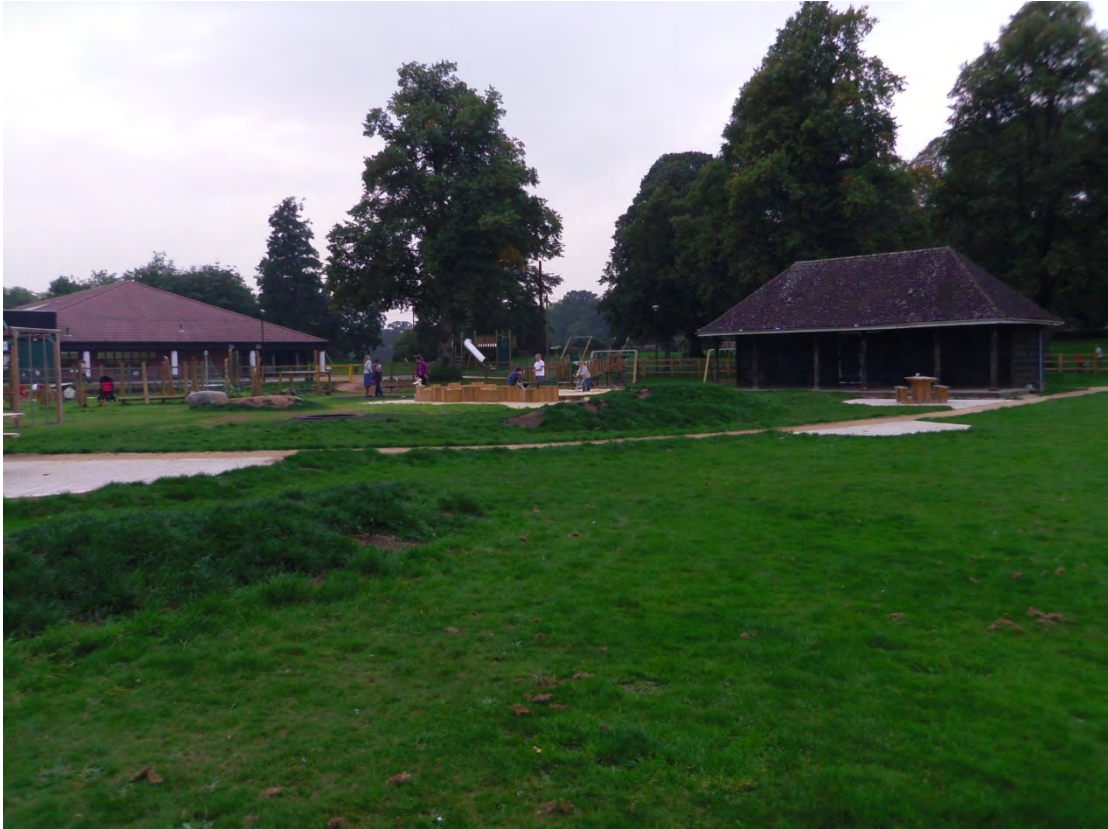
Fig 6: Play area

5.4 The site was re-visited in 2013 to record the extent of groundworks potentially missed. It was noted that not all of the features shown on the plan (Fig 5) had been installed, and that some features, such as the zip-wire, were not in the position indicated on the plan. Extensive ground disturbance must have taken place for the insertion of the paths and concrete areas and some of the pieces of equipment, such as the sunken trampoline. The grassed banked mounds built up in areas around the play area are suffering from extensive erosion and fragments of roof tile are being exposed (Fig 9)
