## **Summary**

It is intended that the former doorway on the north -side of the gatehouse at Kenilworth Abbey be opened up and a new door inserted. At present the ground is considerably higher outside the blocked doorway than inside and historic photographs show that the ground level outside was lower in the 19th century than it is now. Excavation of a 1m square test-pit outside of the door revealed the door threshold overlain by 0.42m of soil. Residual fragments of glazed medieval floor tile were recovered from the overlying soil.

1.1 It is proposed to replace the stone blocking of a disused doorway at Kenilworth Abbey gatehouse with a new wooden door. As the gatehouse is part of the Scheduled Ancient Monument of Kenilworth Abbey (SAM No. 35115) it was a condition of Scheduled Monument Consent that a programme of archaeological work, comprising the excavation of a 1m square test-pit north of the blocked doorway was carried out in order to examine the nature of the build-up of ground immediately north of the building.

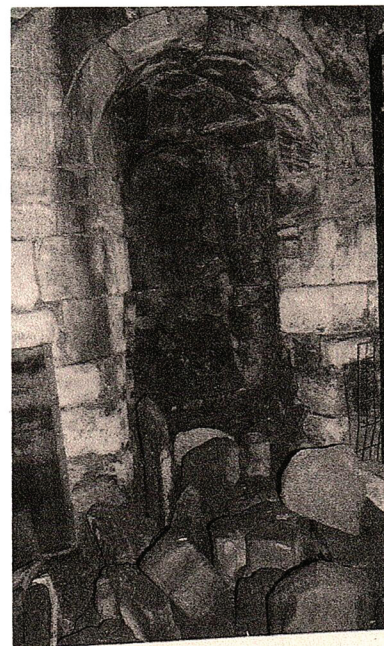
4.3 A 0.05m deep layer of very dark reddish brown sandy loam topsoil overlay layer 2. The doorway itself was possibly a modification to the original building as there are no quoins or mouldings on the exterior (unlike the window above) and from the interior the doorway looks rough (Fig. 7). Hard brown mortar and sandstone rubble had been used to block the doorway. The infilling was a single block thick. There are brick steps leading down from the threshold to the floor inside.

Fig. 7: Interior of blocked doorway
